CHURCHES EA AND E AT SARDIS

Archaeological Exploration of Sardis

By Hans Buchwald

2015

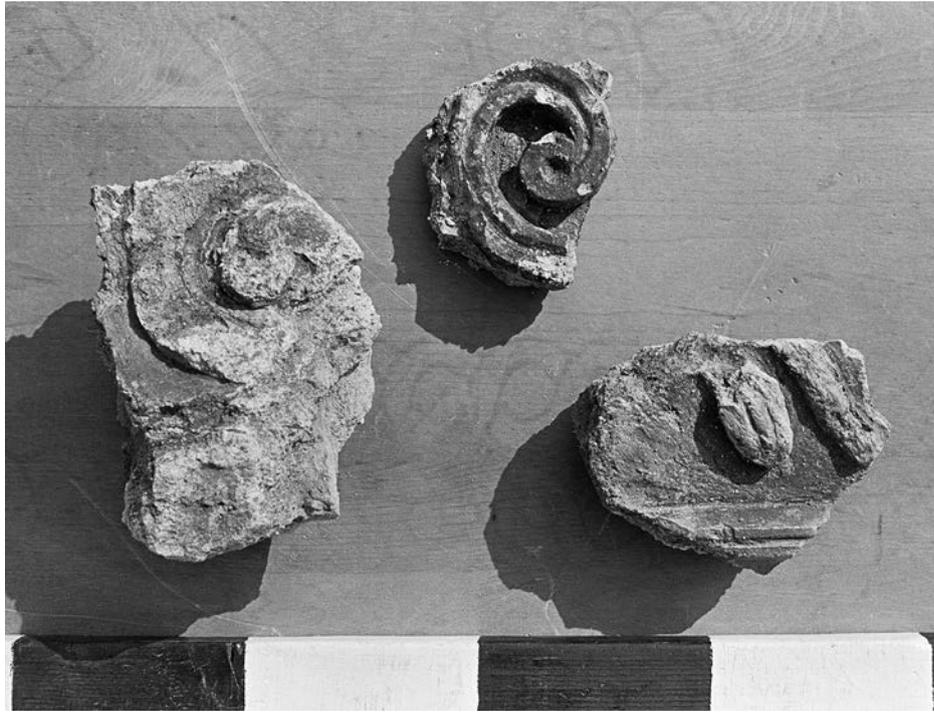
Fig. 29. Church EA revetment in northeast corner of north aisle.

Other remnants of the original marble revetment were found in situ on the lower walls of the church (Figs. 28, 29, 33). The dado consisted of marble plaques of almost uniform size, 0.015 m thick; remains of two courses, 0.22 and 0.24 m high, are preserved. The revetment seems to have been entirely flat, without paneling or other plastic articulation, and the marble has no veining. These characteristics are consistent with the clear, simple floor plan and unarticulated walls of Church EA.

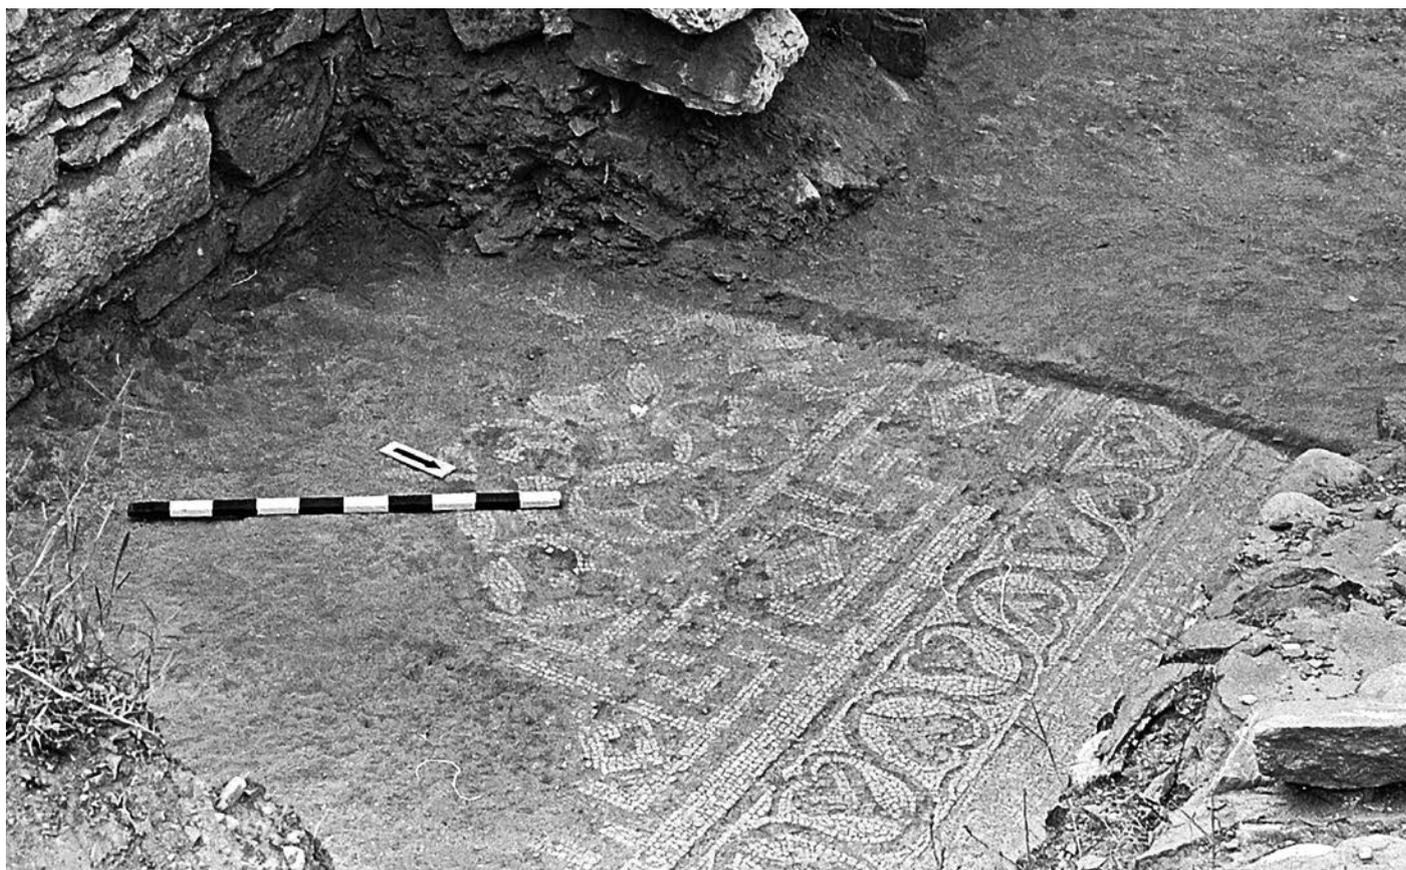
Fig. 33. Church EA northeast corner of north aisle, mosaic floor and revetment, from southwest, 1973.

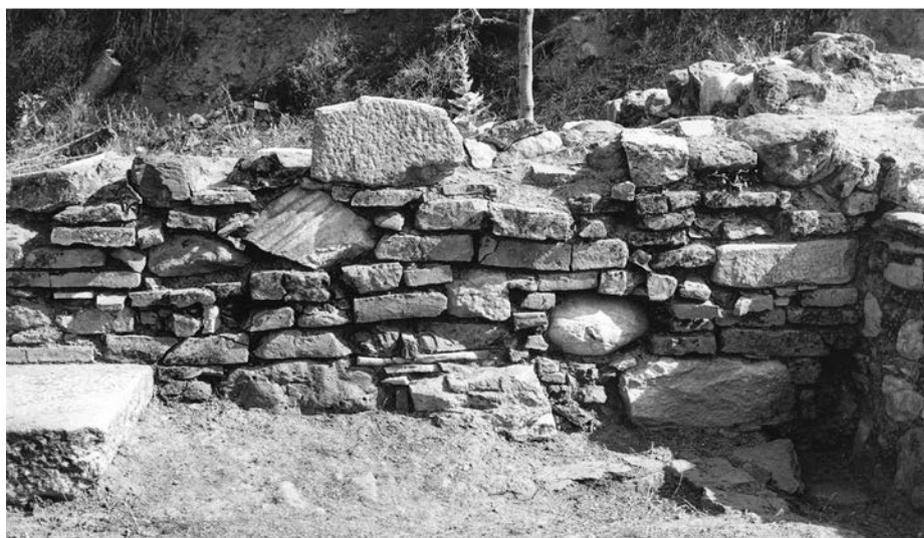
Fig. 89. Church EA nave west wall, with central door to narthex and north jamb, from east, 1973. Original masonry (Type A) at right, medieval reconstruction (Type E) in center, later medieval repair (Type G) at left.

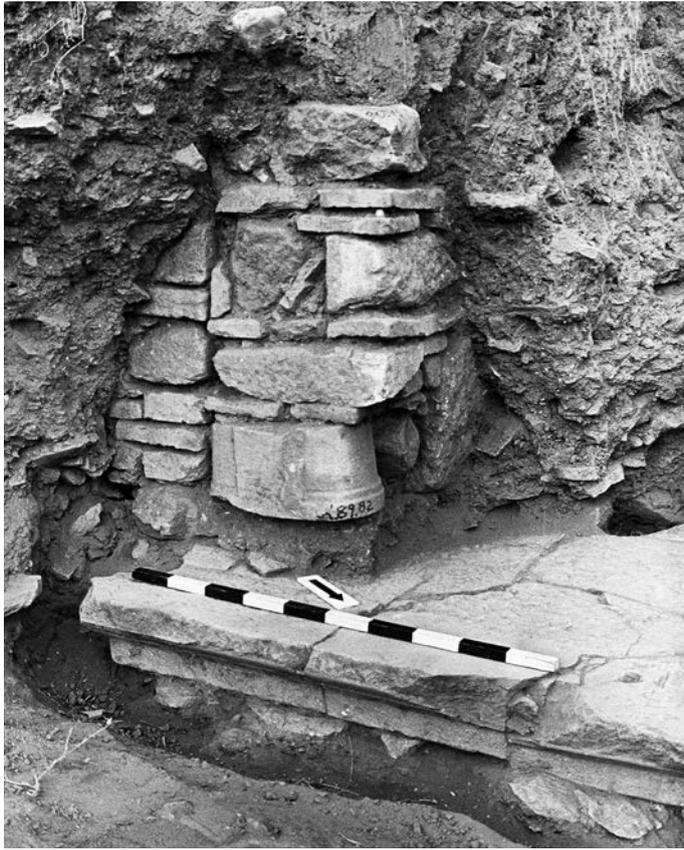
Fig. 97. Church EA door between narthex and north aisle, sealed with Masonry Type F, Masonry Type E left and right of door, from west, 1973.

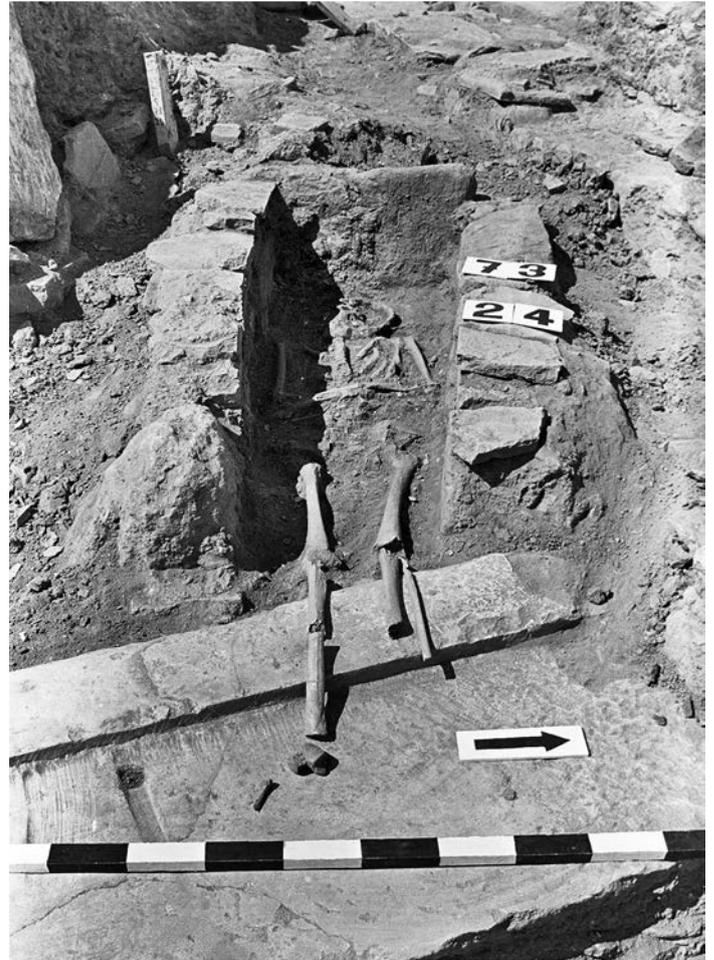
Fig. 98. Church EA door between nave and narthex, south jamb, medieval repair (Masonry Type F) abutting medieval reconstruction at far left (Masonry Type E), from northeast, 1973.

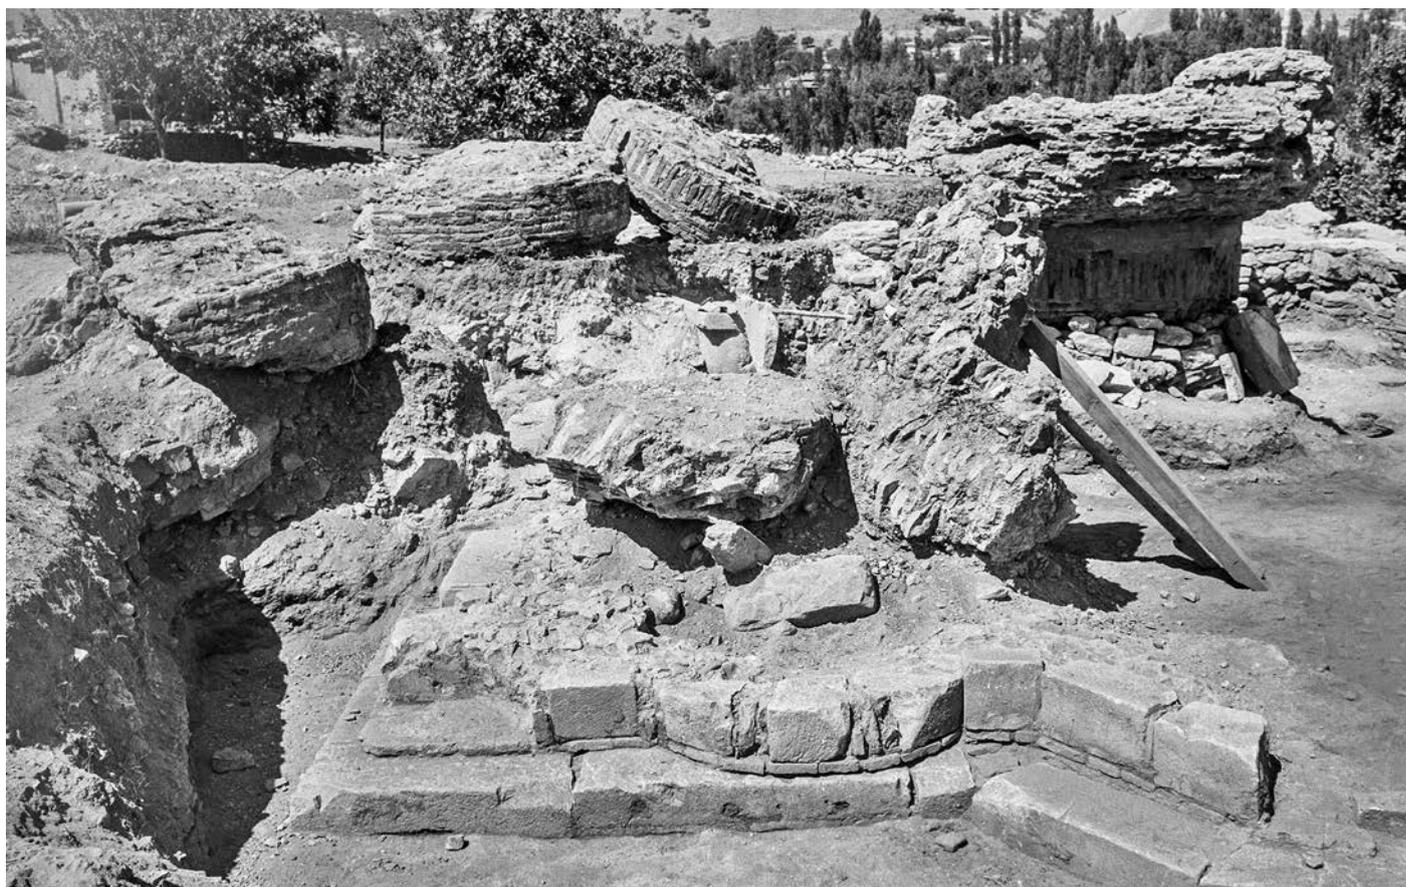
Fig. 183. Church E Masonry Fragment 13, plaster and paint remnants on surface of vault, 1969.

Frescoes were also recorded in Church E, in one of the extant cupolas (Fig. 183) and in the Pseudocrypt (Figs. 205–9), and the numerous glass tesserae found in the excavation suggest that the central dome and/or the apse contained mosaics. Fragments of thin, flat glass (rose, yellow, pale blue, blackish blue, blackish purple, olive, and green in color) suggest that some of the windows may have had colored glazing.

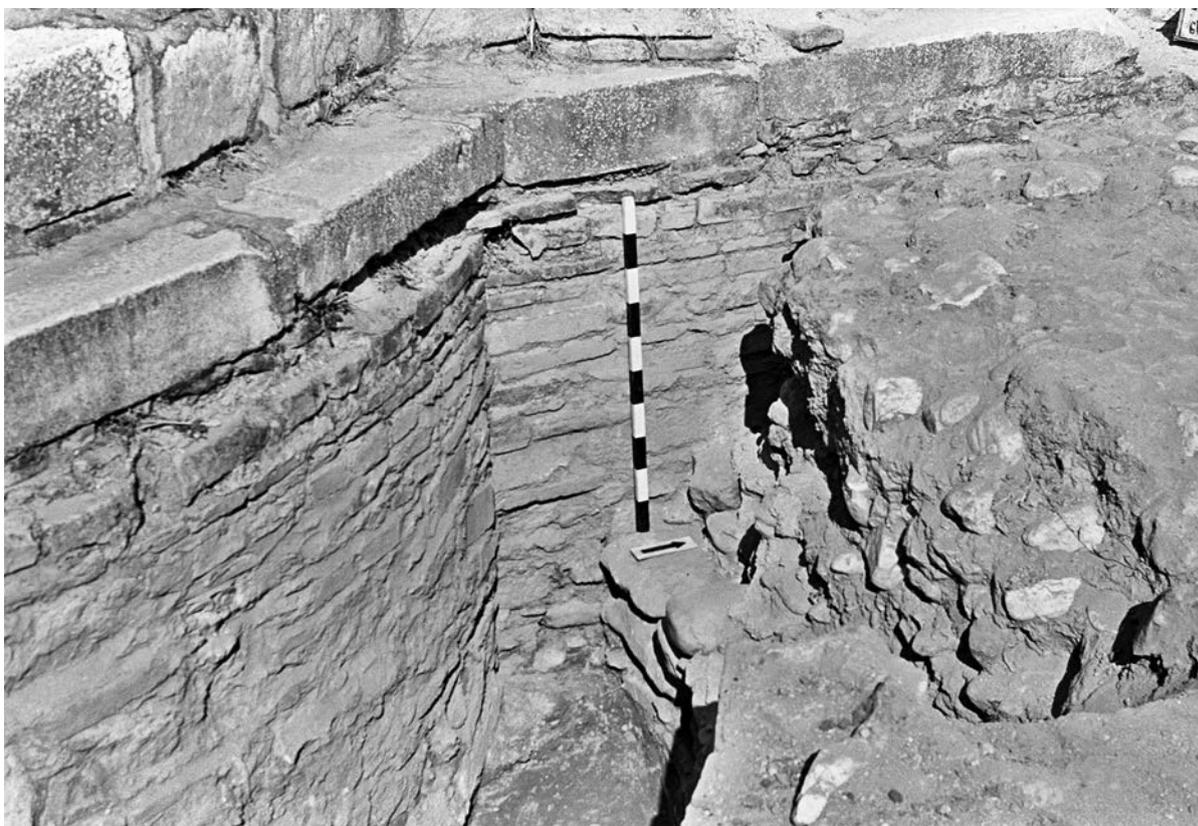
Fig. 187. Church E schematic plan of foundations, 1972.

Remains of a network of wooden tie beams were found in Church E just below the level of the floor and stylobate (Figs. 187, 195, 196). The beams appear to have been used somewhat like steel tie rods or reinforcement bars inside the concrete of modern buildings. While the wood itself was not preserved, the wooden fibers left imprints in the hard, fine mortar that encased them in some places, and numerous iron spikes used to fasten the beams to each other were found at intersections.

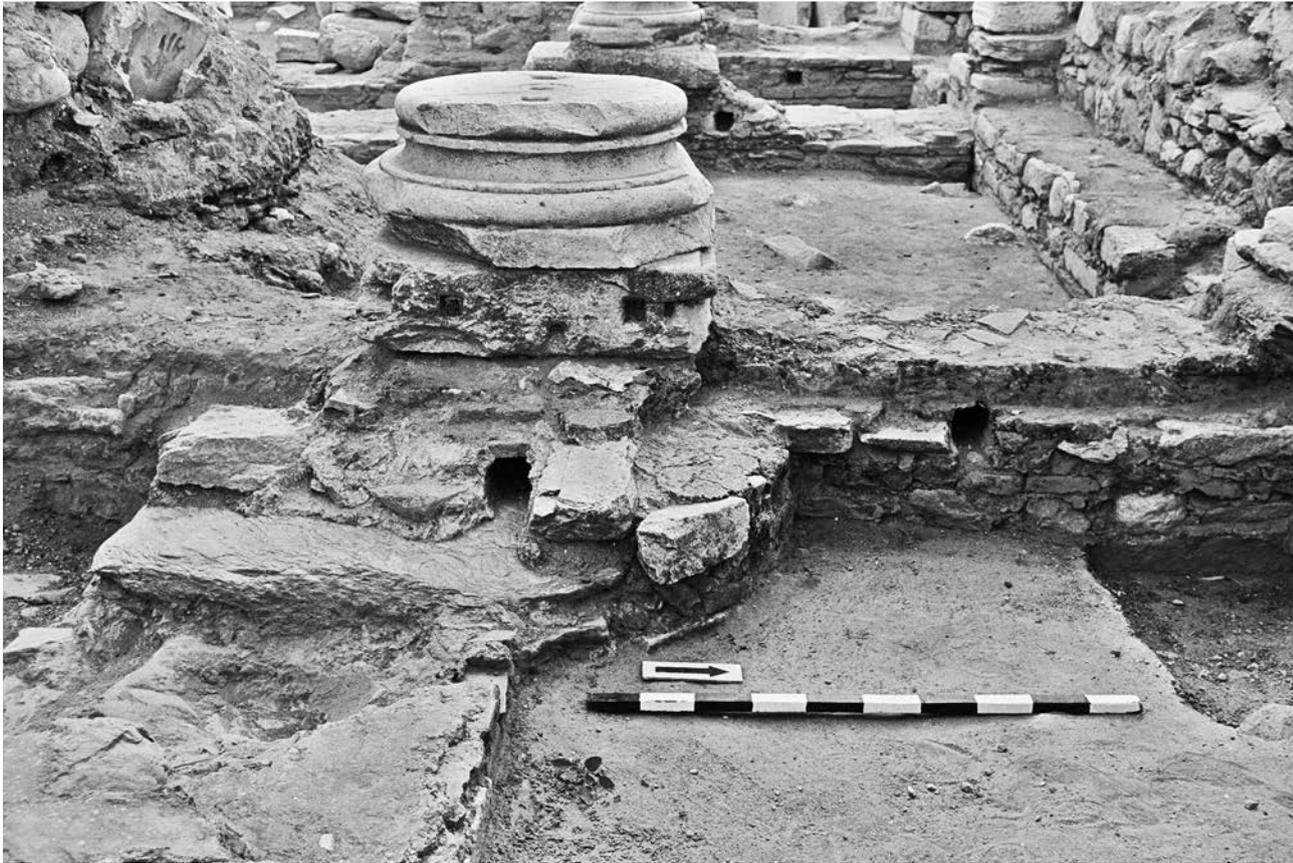
Fig. 195. Church E southeast corner of naos, with channels for wooden timbers in upper surface of foundation, from north 1962. Fragment 17 at rear left.

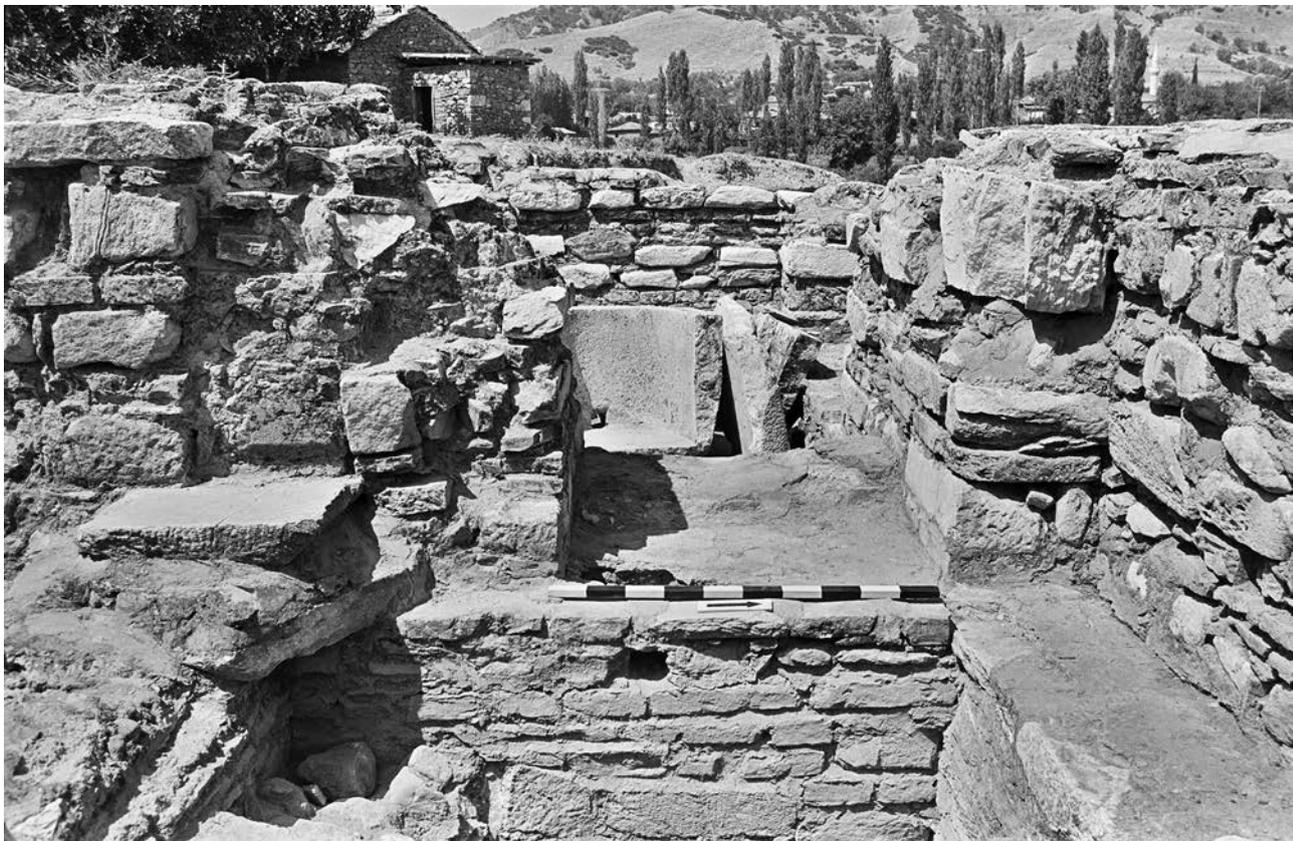
Fig. 196. Church E foundation below central column of north colonnade, from east, 1972.

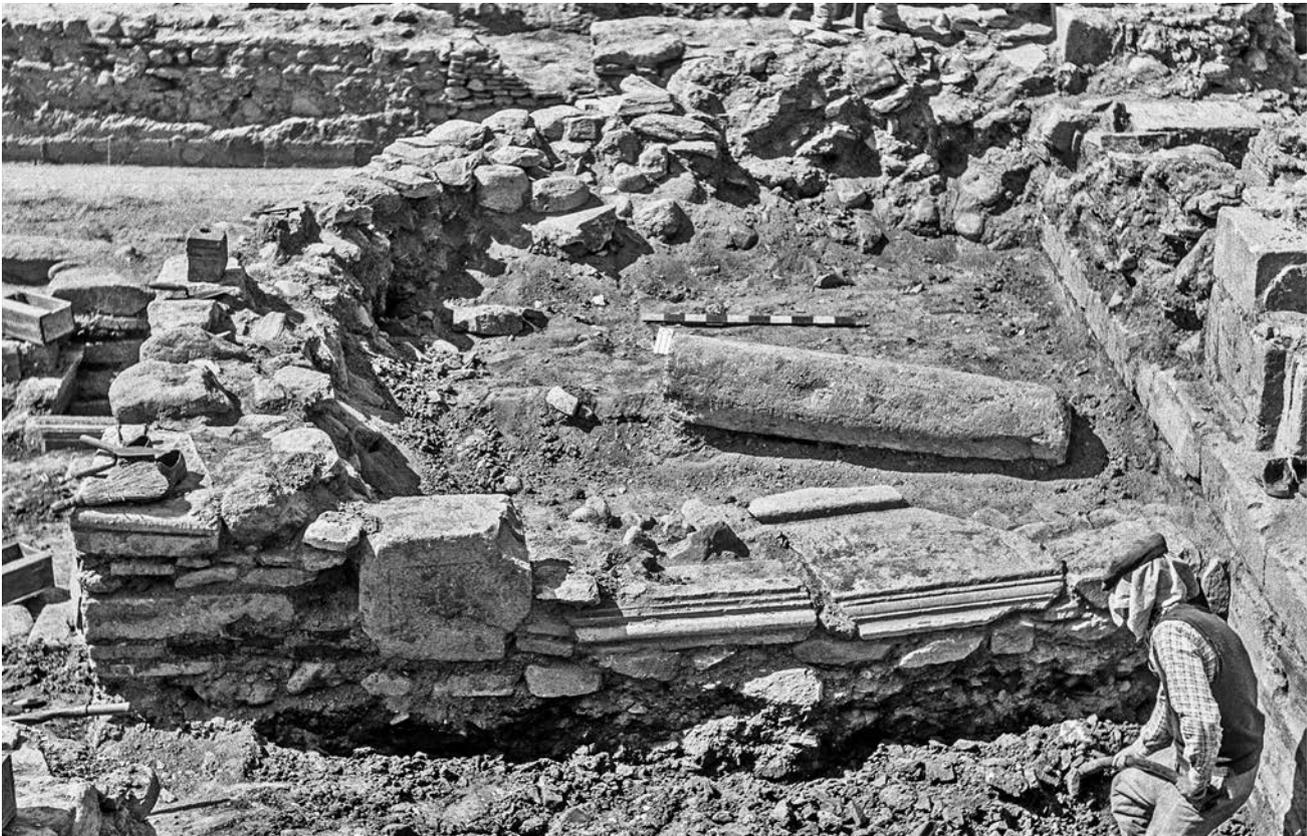
Fig. 200. Turkish addition to west of Church E, with Church E west façade foundation at far left, from north, 1962.

added to the west (Figs. 12, 200, 201). The eastern part may have been used for industrial purposes, centered around a fire underneath the main cupola, which, without glass in the windows of its drum, would have provided an excellent flue. The narthex, together with the new additions to the west, appears to have served domestic functions. The fact that Church E was not converted into a mosque suggests that perhaps another, larger and more important church was in good condition in Sardis during the thirteenth century. Church E was utterly destroyed, most probably by the earthquake of 1595, some 350 years after its construction.

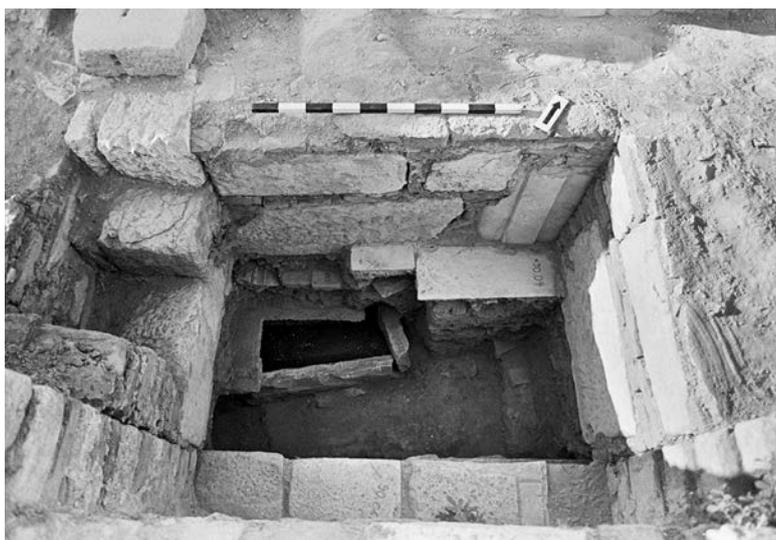
Fig. 201. Turkish addition to west of Church E, Church E west facade at far right, from south, 1962.

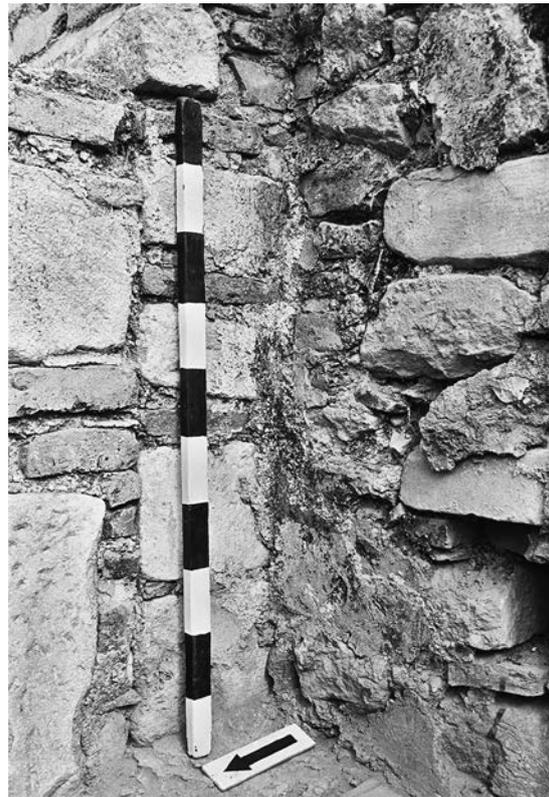
Fig. 207. Church E Pseudocrypt southwest corner, with wall paintings, from northeast, 1972.

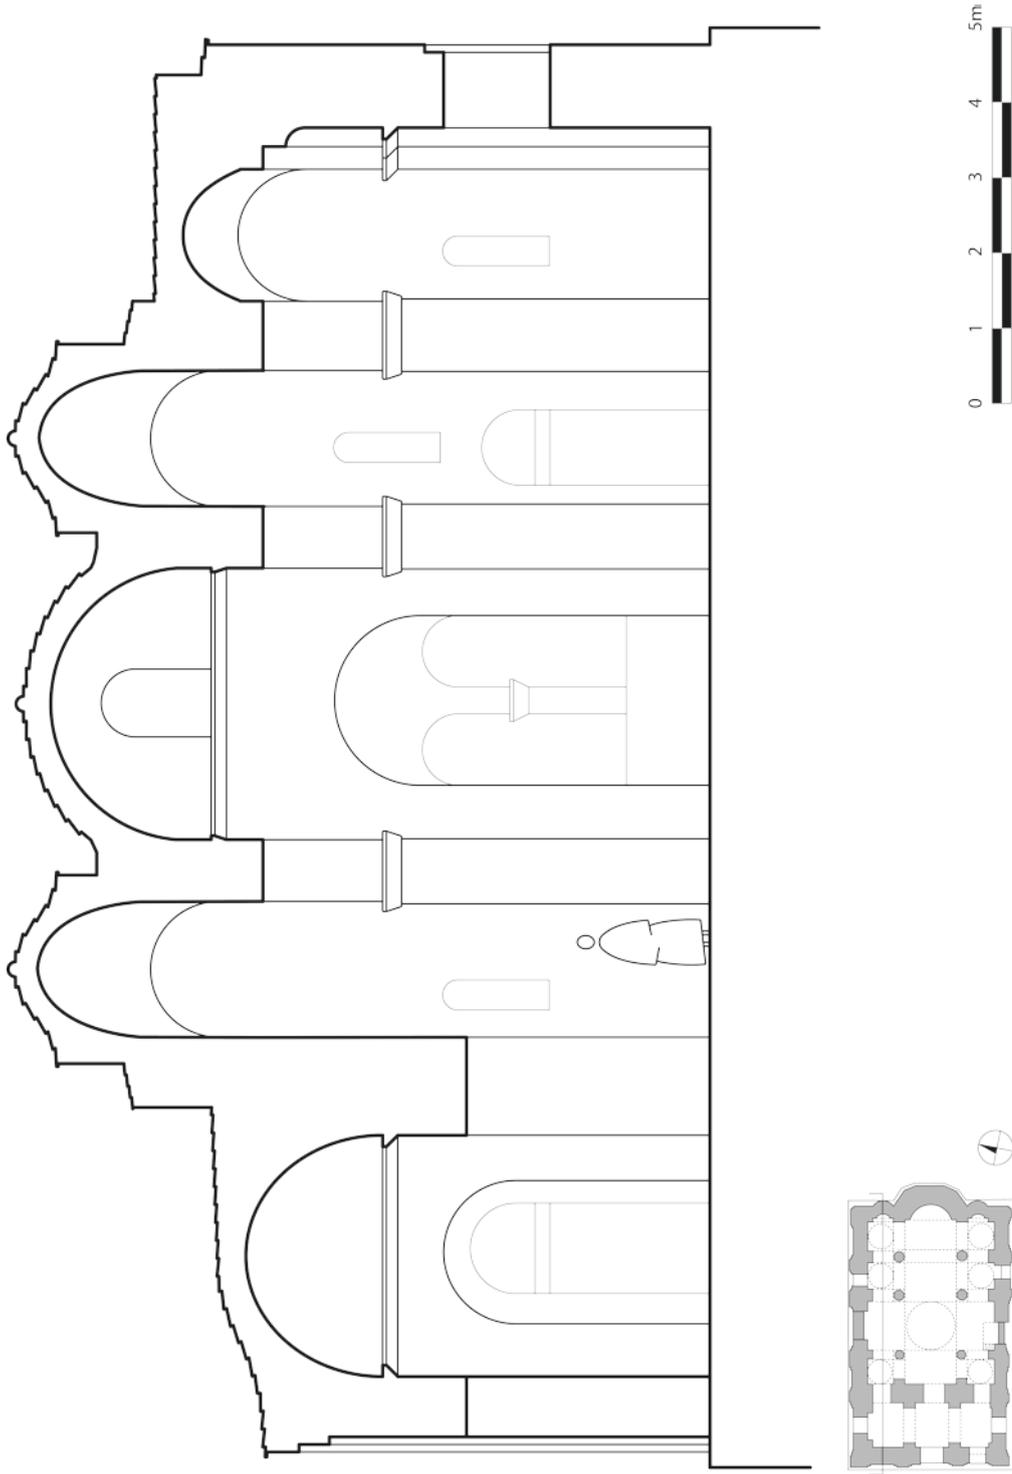
Fig. 216. Church E reconstructed longitudinal section on major axis looking north.

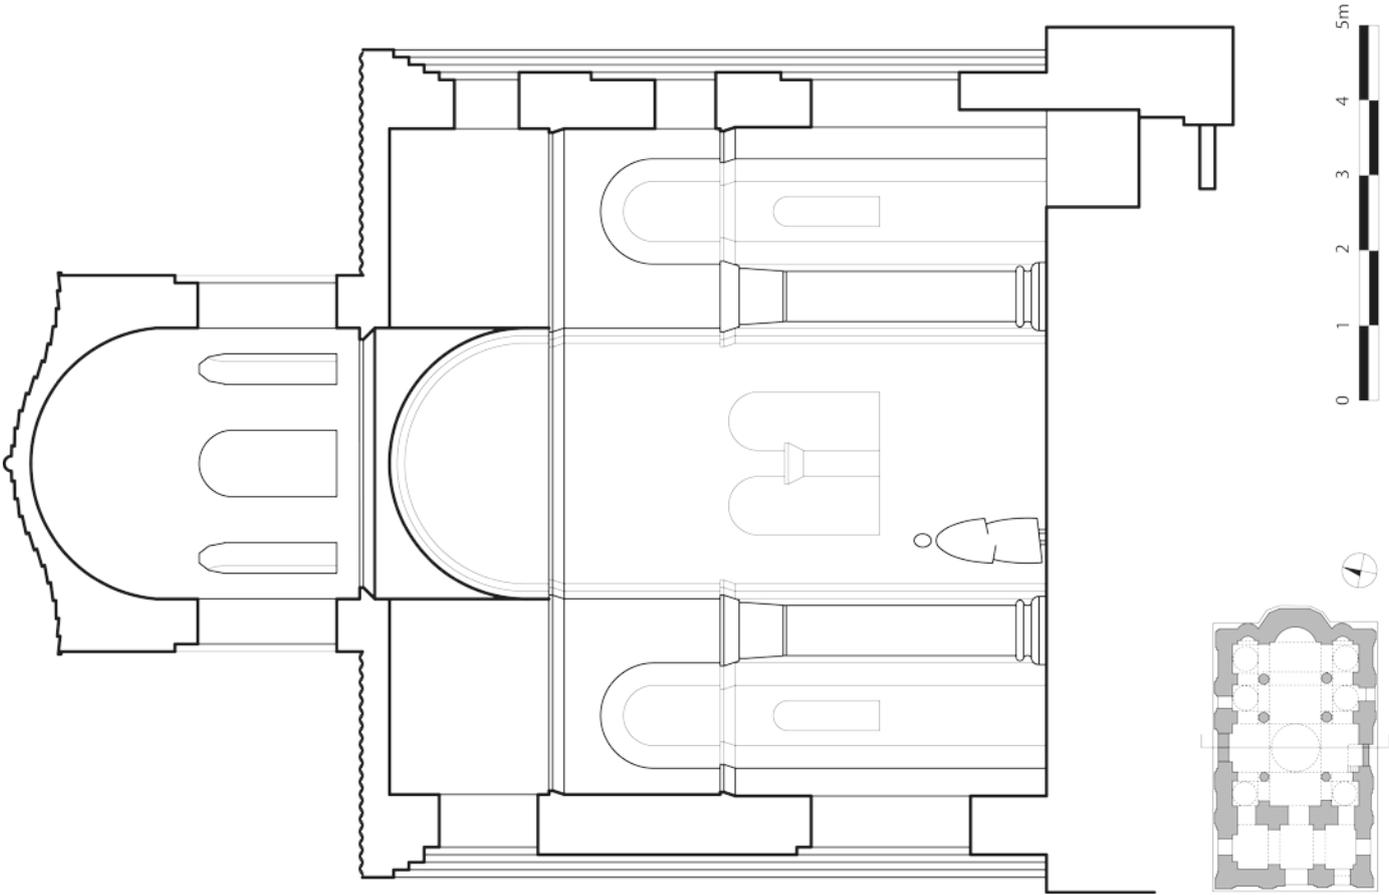
Fig. 217. Church E reconstructed longitudinal section on axis of north aisle looking north.
